**Engineer's Report**

**KLONDIKE CANYON GEOLOGIC HAZARD ABATEMENT DISTRICT**

**FISCAL YEAR 2023-24**

**May 24, 2024**

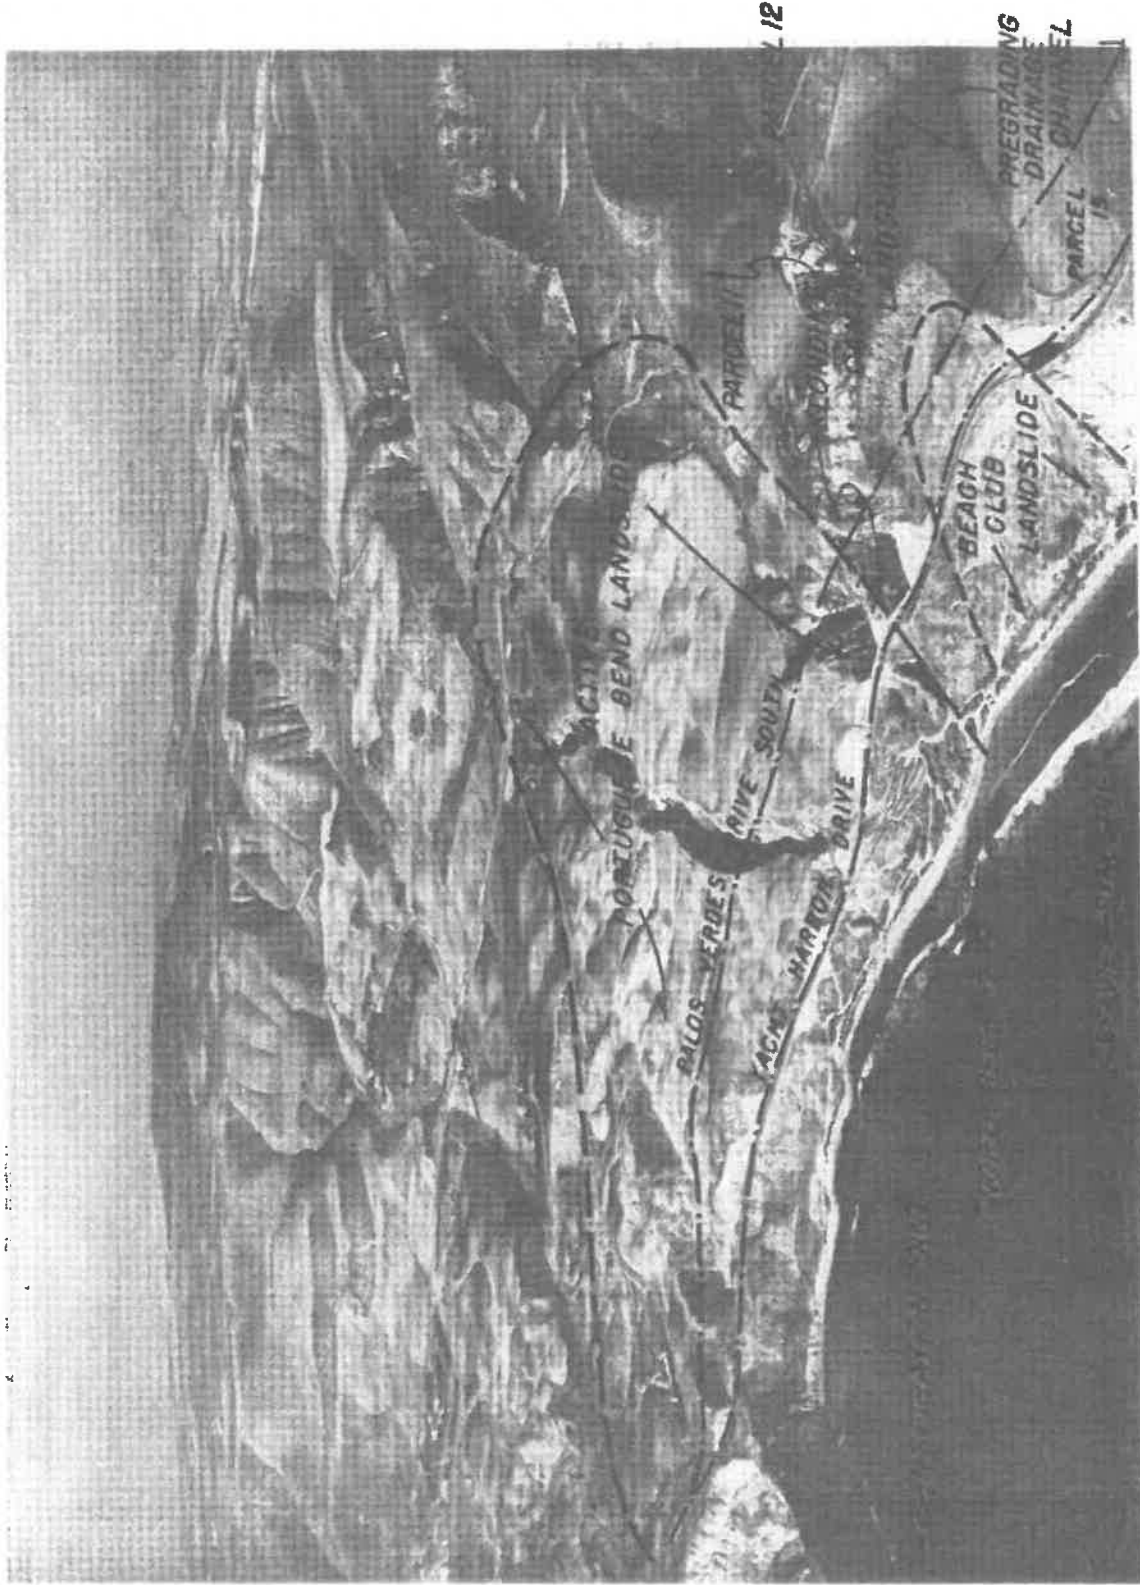
**PORTUGUESE BEND AREA — NOVEMBER 28, 1931**

*Approximate Extent of Klondike Canyon Landslide  
 Photo courtesy of Spence Air Photo Collection - Dept. of Geography - U.C.L.A.  
 PLATE III*

Photos predating the grading of the Seaview Tract show a relatively prominent drainage channel crossing the northwest portion of the tract (see

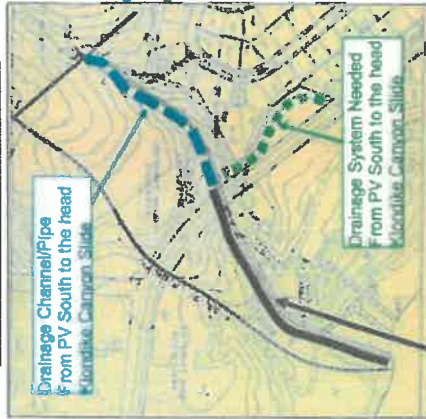
**Step 1 & Step 4**

Klondike Canyon - Drainage Map.

..... **Step 1**  
..... **Step 4**

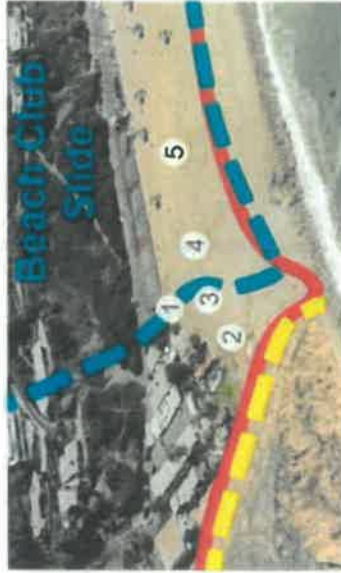
**Step 2**

5 active Wells ~ 400K Gal/day  
210 days to remove 2023 rains (have 2-wells now)

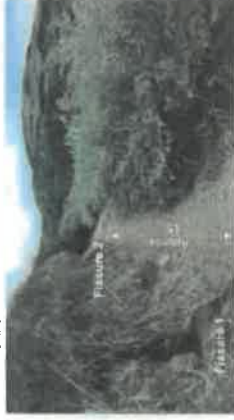
**Step 3**

Fill Fissures Head of Klondike Slide

Remove earth to relieve pressure in PBC
